FLOOD PLAIN INFORMATION

QUINNIPIAC RIVER

SOUTHINGTON

PREPARED FOR
THE TOWN OF SOUTHLINGTON, CONNECTICUT
BY
DEPARTMENT OF THE ARMY
NEW ENGLAND DIVISION, CORPS OF ENGINEERS
WALTHAM, MASSACHUSETTS
JANUARY 1970

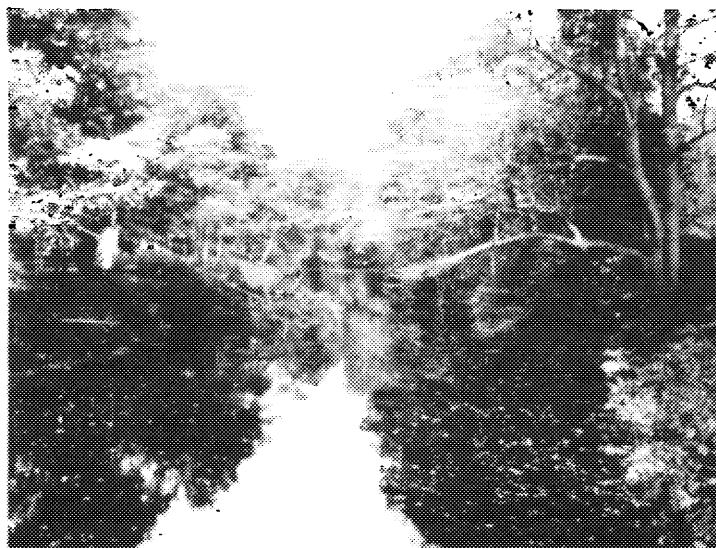
Photo #1. View of channel looking upstream from Johnson Avenue in Cheshire. Note the heavy vegetative growth on the river banks.

Throughout the area of study, the Quinnipiac River is characterized by a narrow channel incised 4 to 6 feet in a broad flood plain. In general, the river banks support a very heavy growth of weeds and brush. In the northern section of town, there are areas where the brush has grown completely across the channel. Numerous trees are growing in and immediately adjacent to the channel and in several locations dead tree trunks have fallen into the river and act as small dams as floating debris becomes lodged against the fallen trunk. See photos #1 & #2.

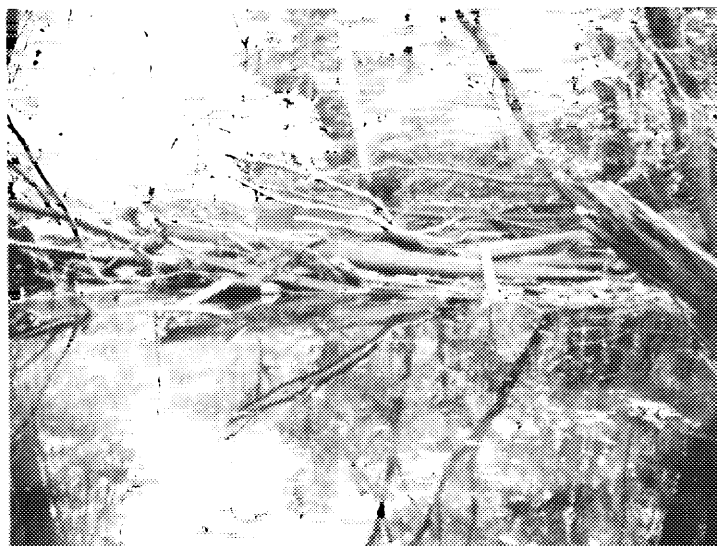
Photo #2. View of fallen tree completely across river just south of Meriden - Waterbury Turnpike. Floating debris is being trapped here and a small dam has been created.

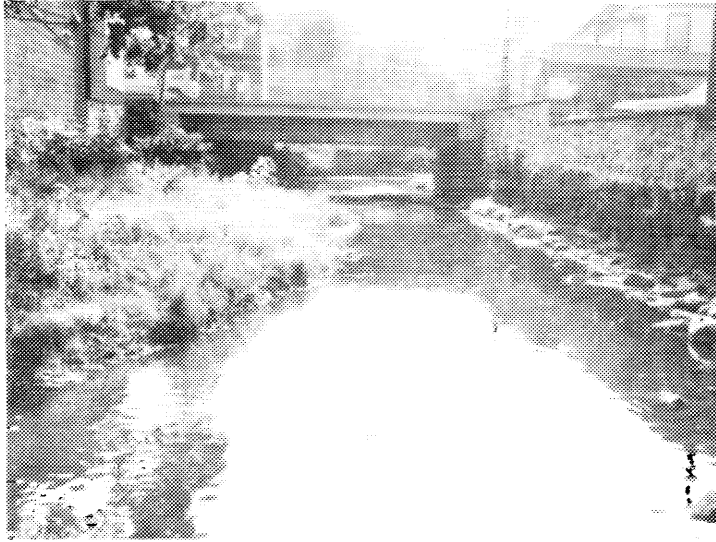
Photo #3 . View of West Main Street bridge looking downstream.

At the time of this study, there were 20 bridges, 2 box culverts, and 1 stone arch which carry vehicular and railroad traffic across the Quinnipiac River. See photos #3 thru #9. All of the existing crossings create a restriction to flood flow to some degree because of the need to build the approaches on fill

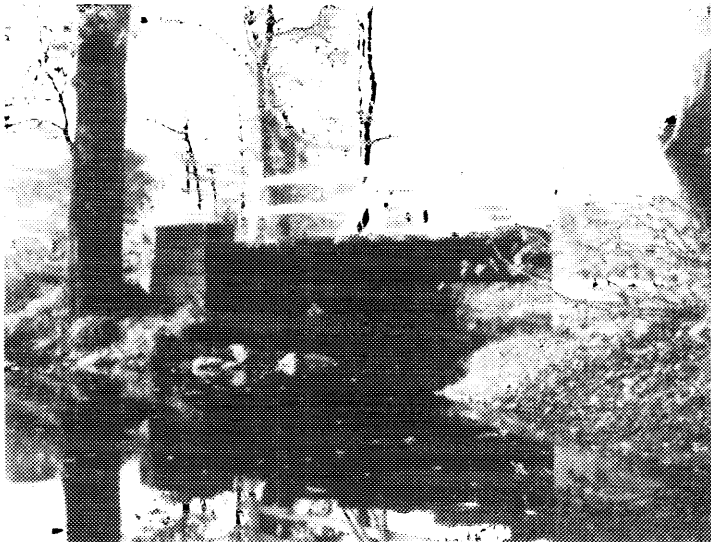
Photo #4 . View of Hart Street bridge looking upstream.
This is a small, narrow, low bridge with an inadequate waterway opening.

A review of this table and the plans and profiles of the flood plains indicates that 12 of the existing structure openings will pass a flood equal in magnitude to the Standard Project Flood providing they are not blocked by debris. Only 1 of the structures listed, Hart Street, will be inundated by a flood equal in magnitude to the Intermediate Regional Flood but in several other areas a flood of this magnitude would make the approaches to bridges impassable. Twelve of the structure openings, however, will be underwater during a flood equal in magnitude to the Standard Project Flood.

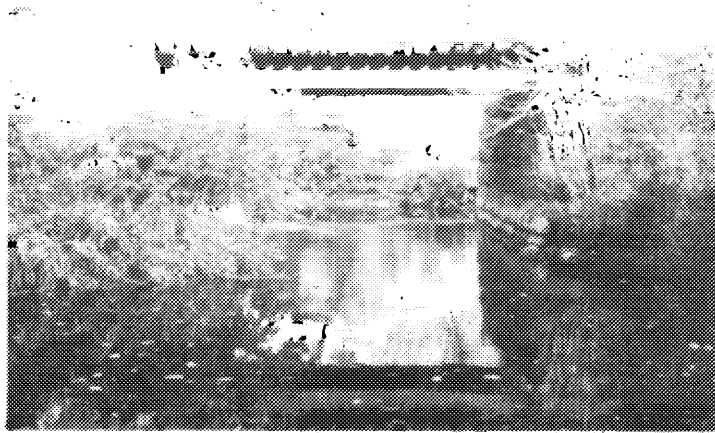
Photo #5 . View of railroad bridge at station 375+00, looking upstream.

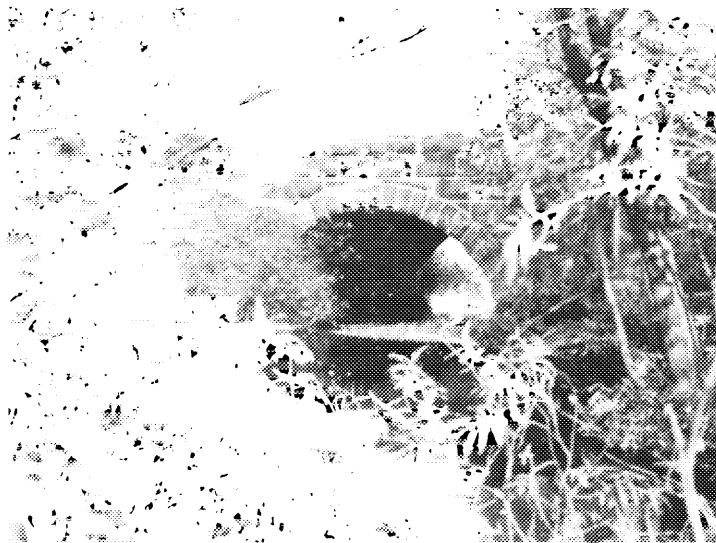
Photo #6. View of railroad arch at station 433+00, looking downstream.

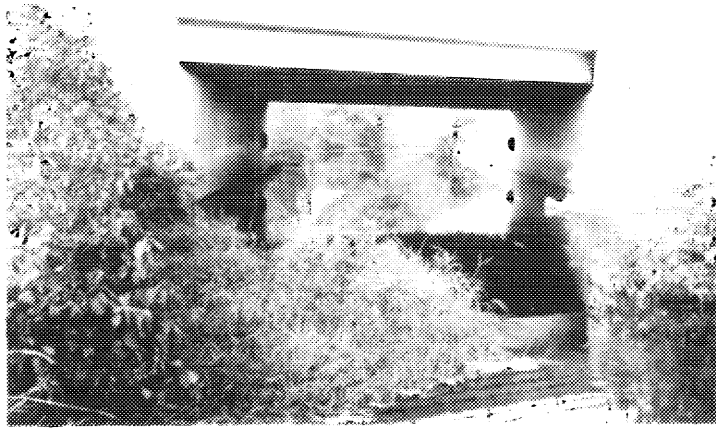
Photo #7 . View of Spring Street bridge looking upstream. Note heavy growth on banks, particularly upstream of bridge.

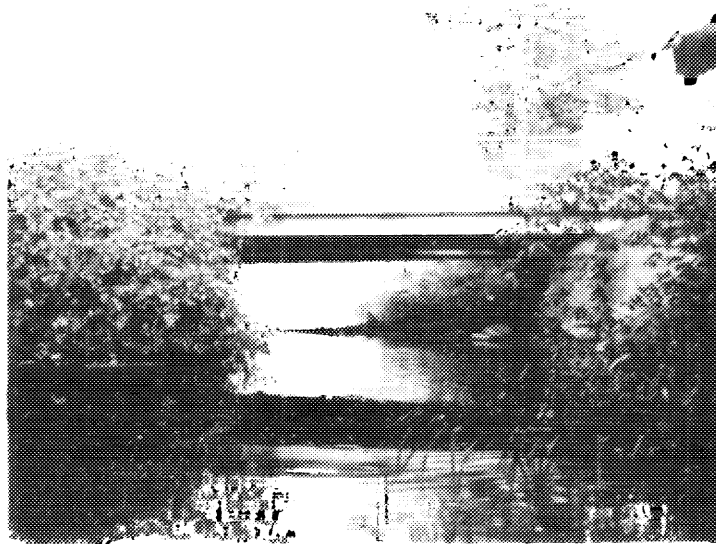
Photo #8 . View of West Queen Street bridge looking upstream.

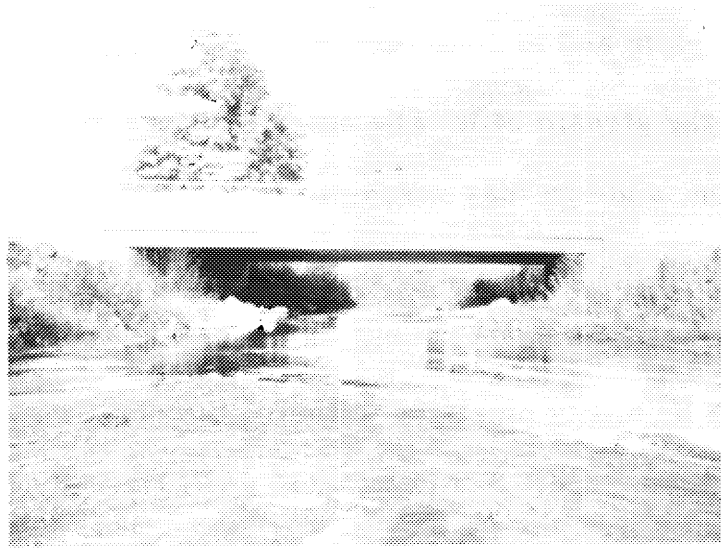
Photo #9 . View of Newell Street bridge looking upstream. Silt in foreground has been washed downstream from recent construction upstream.

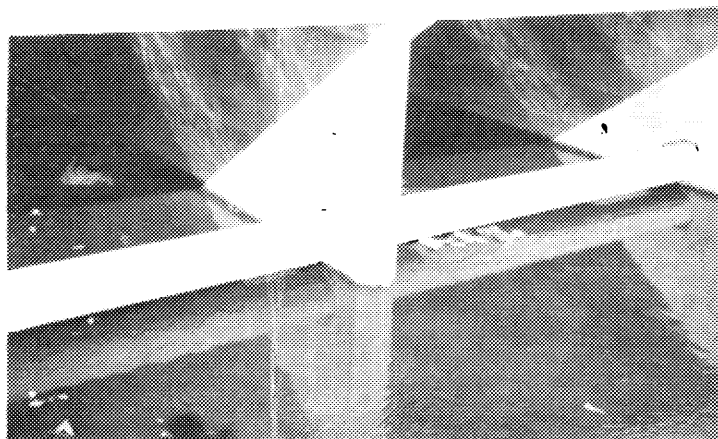
Photo #10. View of utility pipe just above water surface at the Mill Street bridge. Note debris lodged under pipe.

in the flood plain and to construct piers and abutments in and adjacent to the stream bed. The newer bridges form less of a restriction and are less susceptible to blockage from floating debris than the older bridges. However, the effective waterway opening on several bridges, both new and old, has been reduce by utility pipelines crossing the river under the roadway of the bridge. See photos #10 and #11.

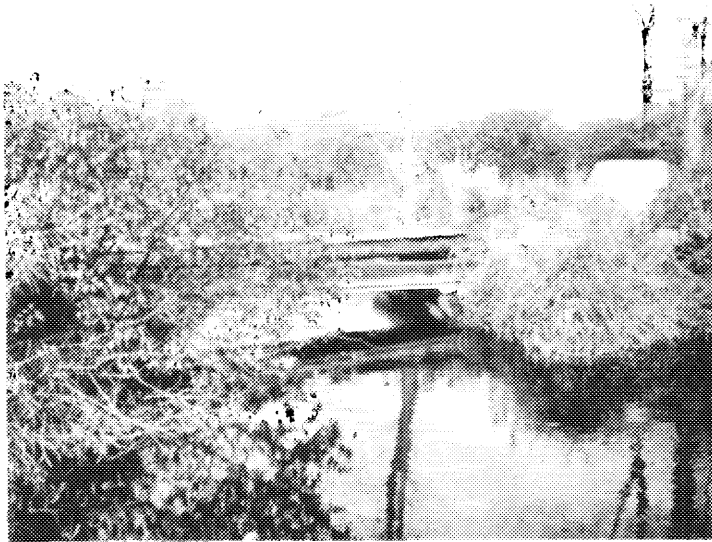
Photo #12. View of sewer pipe and supporting channels at station 338+00 with pole and plank footbridge in the background, both susceptible to blockage from floating debris.

In addition to the vehicular and rail crossings indicated above, there are three pipe crossings and numerous private bridge crossings for pedestrians and farm equipment. Two of the pipe crossings and several of the private bridge crossings form definite restrictions to flood flow and are highly susceptible to blockage from floating debris. See photos #12 and #13. At the time of this study, the closely spaced concrete piers supporting the pipe crossing 500 feet south of Atwater Street were completely blocked with debris and the entire structure was acting as a small dam. See photo #14.

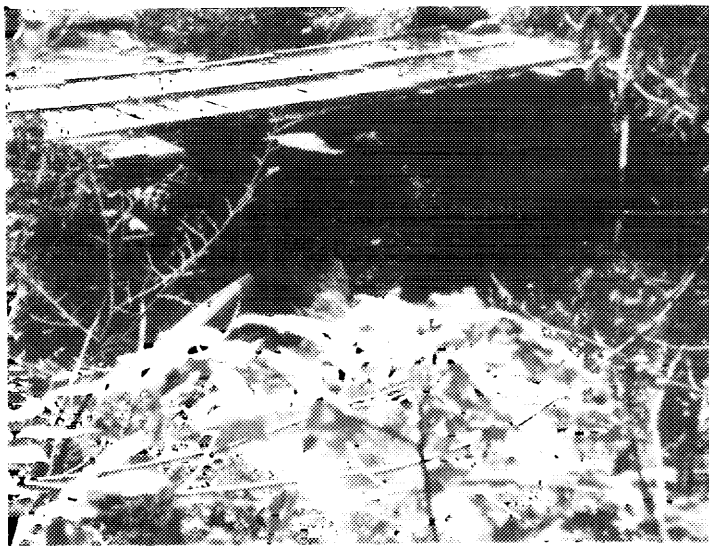
Photo #13. View of private bridge crossing at station 126+00. Note collection of logs and other debris at this bridge.

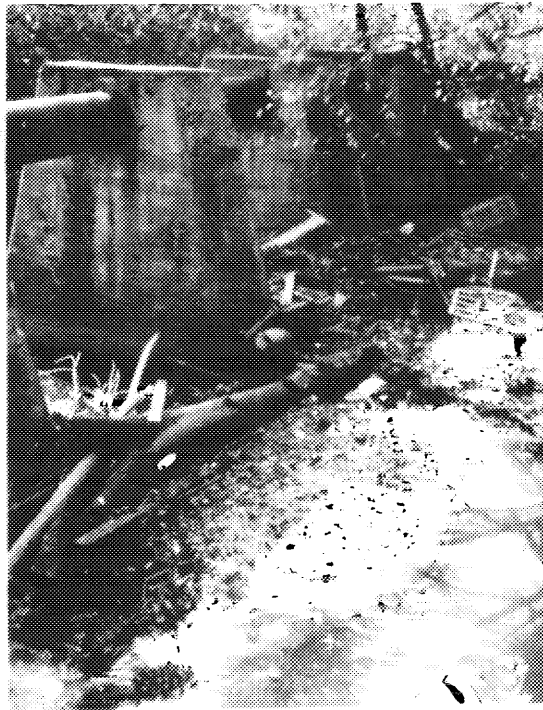
Photo #14. View of sewer pipe crossing 500 feet south of Atwater Street. The closely spaced concrete piers have prevented the passage of floating debris and the entire structure is acting like a small dam.

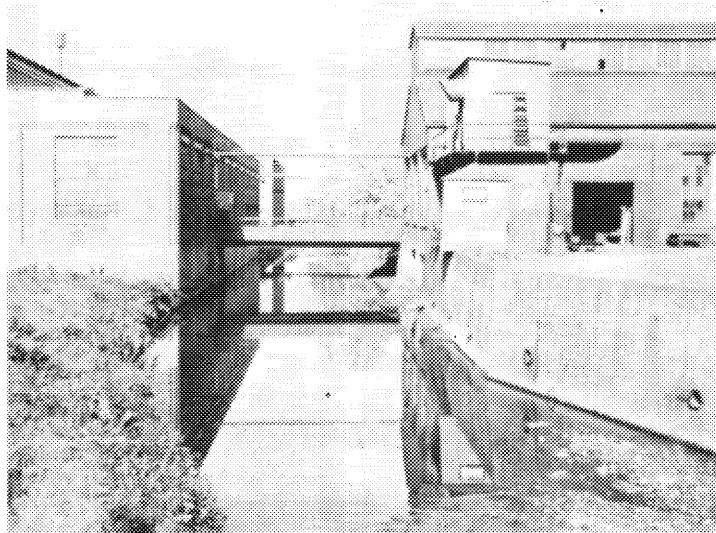
Photo #15. View looking upstream from Center Street. Industrial building walls form the sides of the channel in this area.

In the past, development in the flood plain has been limited in the most part to industrial structures. In fact, some of these industrial structures are so close to the channel that the walls of the buildings form the sides of the channel. See photo #15. With the increasing demand for land in our urban areas, residential, commercial and new industrial development have taken place in

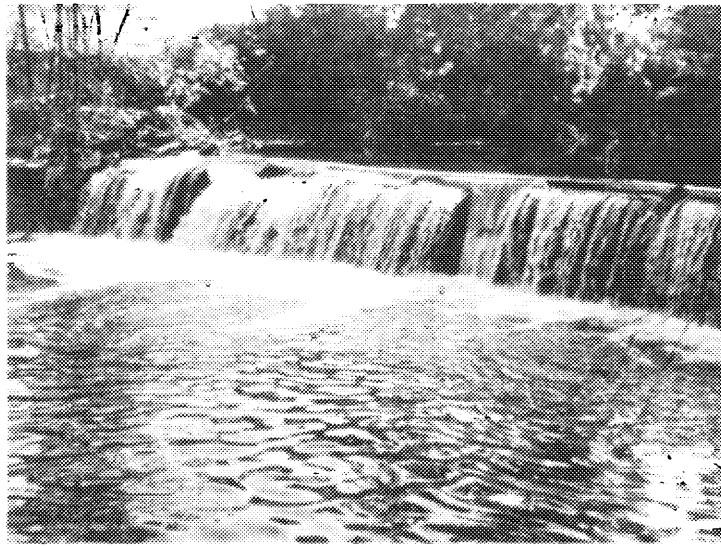
Photo #16. View of small dam at station 173+00.

A dam will also raise the elevation of the water surface upstream from the dam. A picture of a dam no longer being used for the purpose for which it was constructed is shown in photo #16.

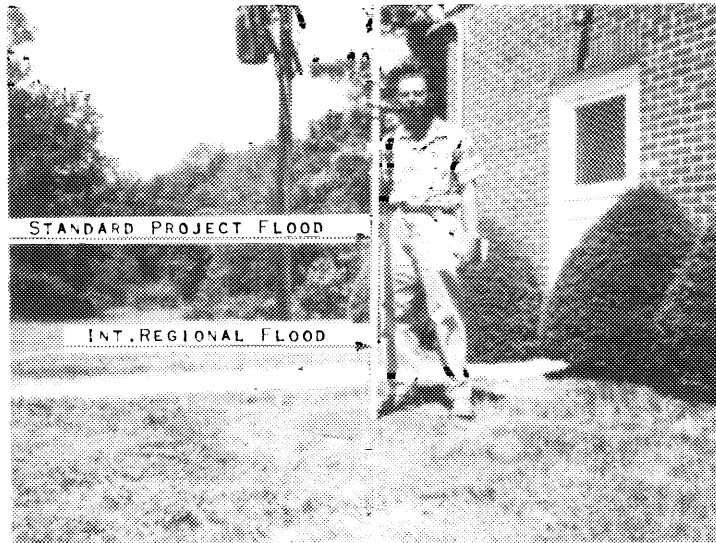
Photo #17. Flood heights at pumping station on Meriden
- Waterbury Turnpike.

Photos 17 thru 20 indicate the heights that would be reached by the study floods on buildings now constructed within the flood plain.

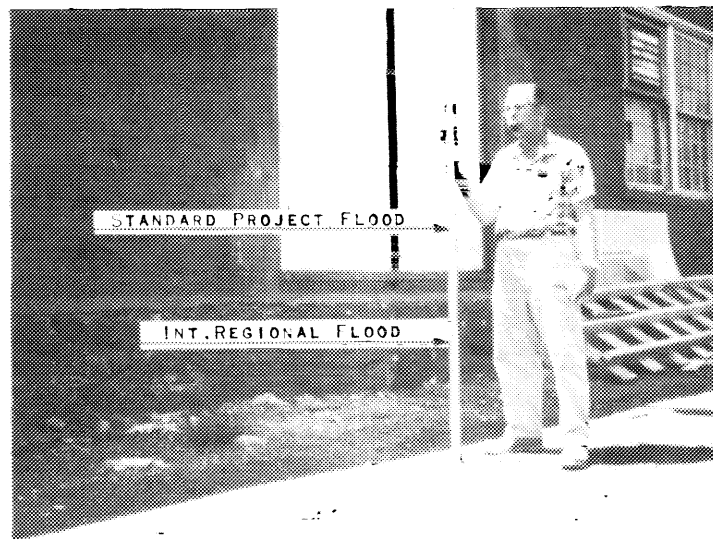
Photo #18. Flood heights at Alsop building on South Main
Street.

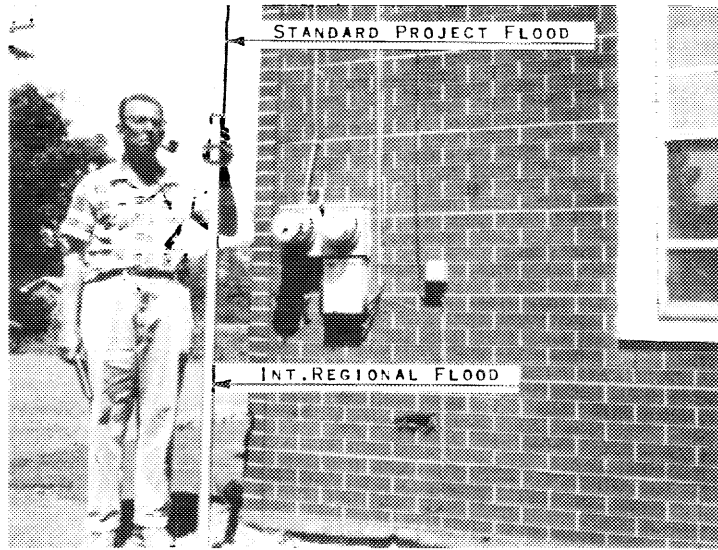
Photo #19. Flood heights at Pexto building on Center Street.
